Mainline 6B 2012 Maintenance and Rehabilitation & Line 6B Replacement Projects
IDEM Water Quality Certification Independent Environmental Monitor Weekly Observation Report

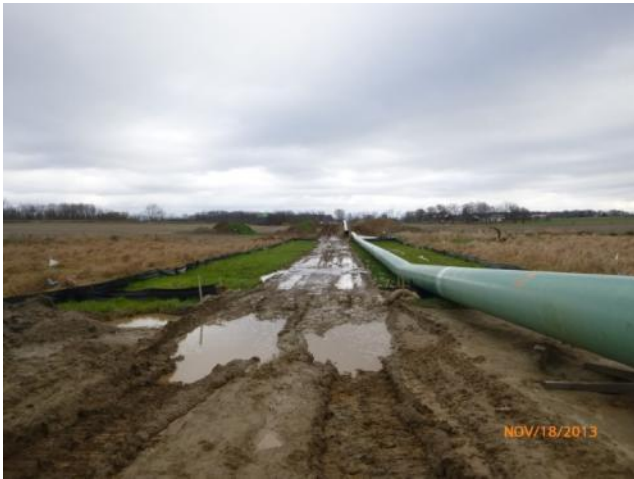
Muddy wet conditions on ROW after recent rain/wind, w-516-a

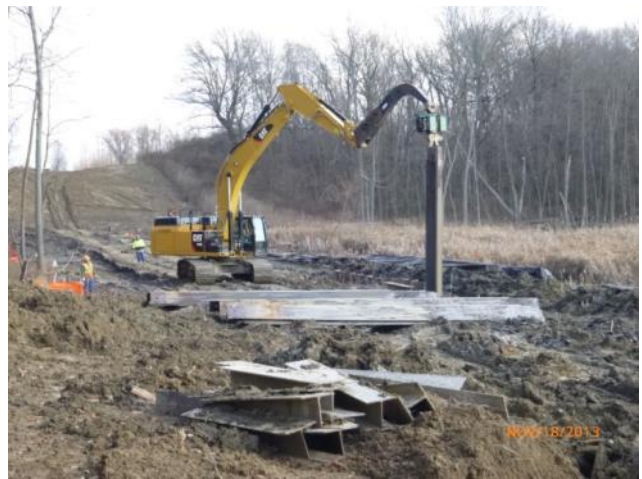
w-497c Sheet piling removal of backfilled pipeline.

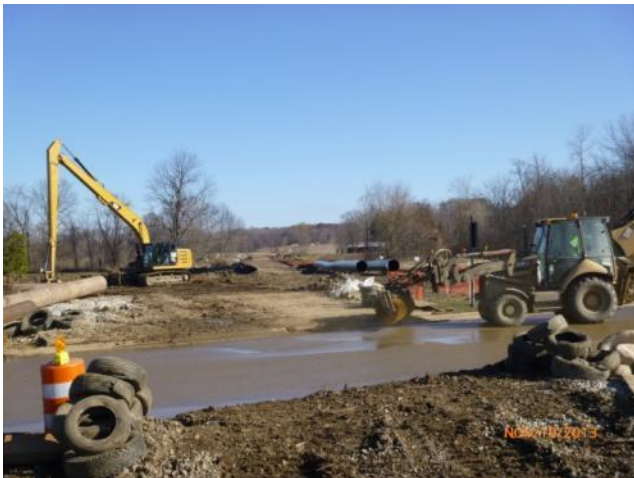
Rd crossing cleaning by pipeline sweeps continues daily.

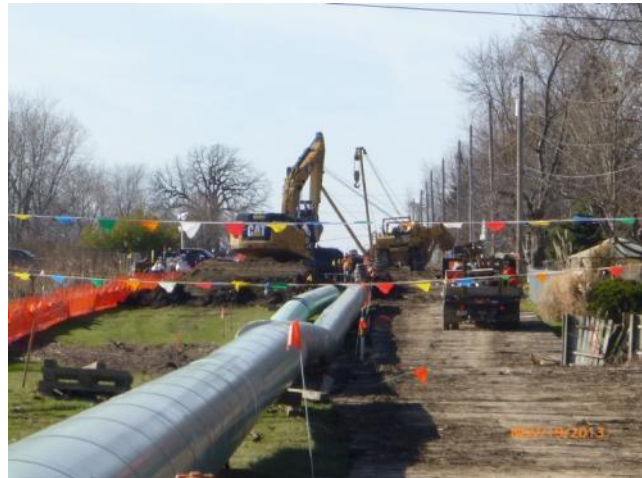
Construction continues within ROW boundaries at MP 482

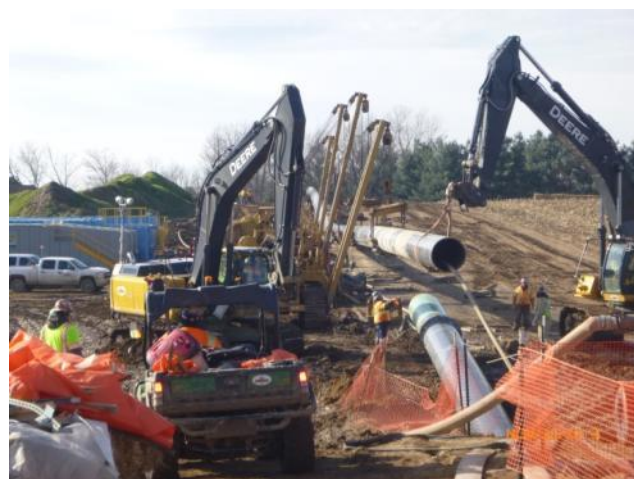
w-496-c HDD pull through and tie-in was in compliance.

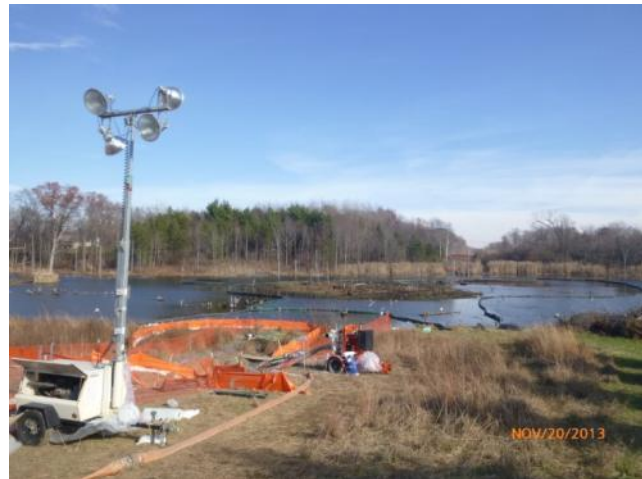
Turbidity curtains, silt fence, and lights for monitoring w-496-c.

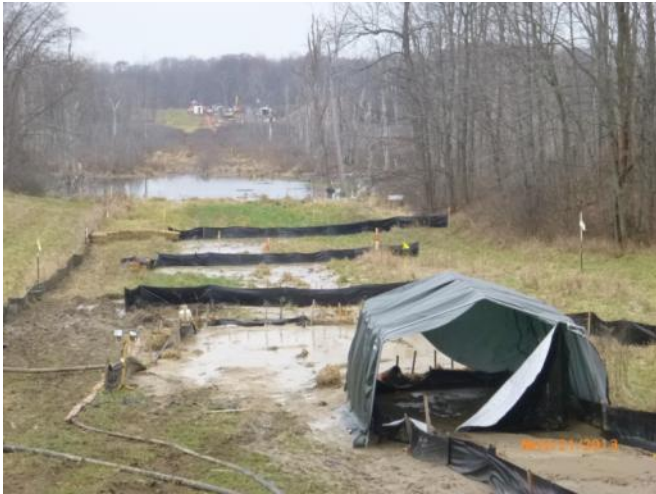
HDD of w-517-e drilling mud fully contained by ECD's

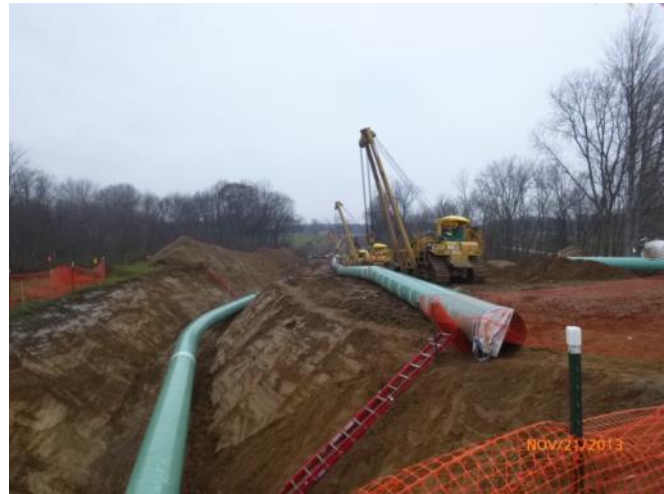
Tie-in crews working at E. Emery rd East of w-516-b

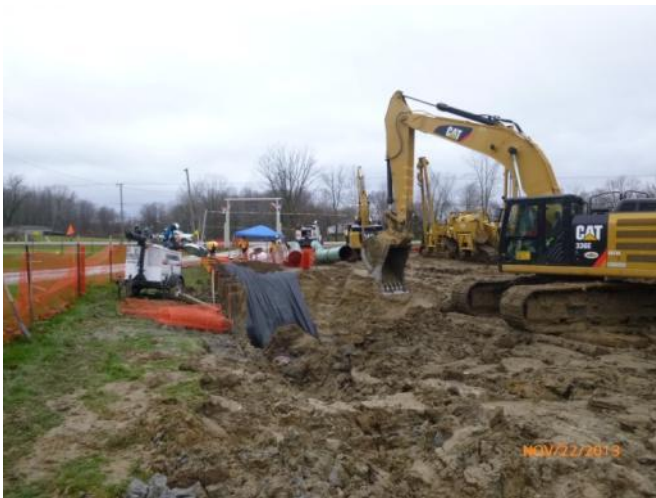
Hwy 421 tie-in progress at East road bore

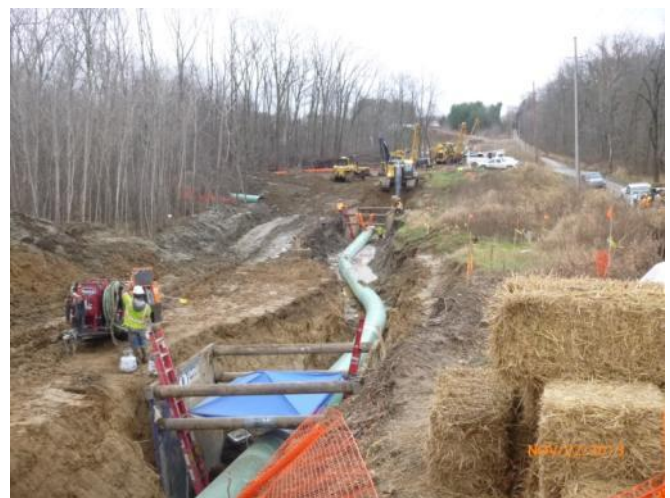
Tie in sections West of w-495-a off Division rd.

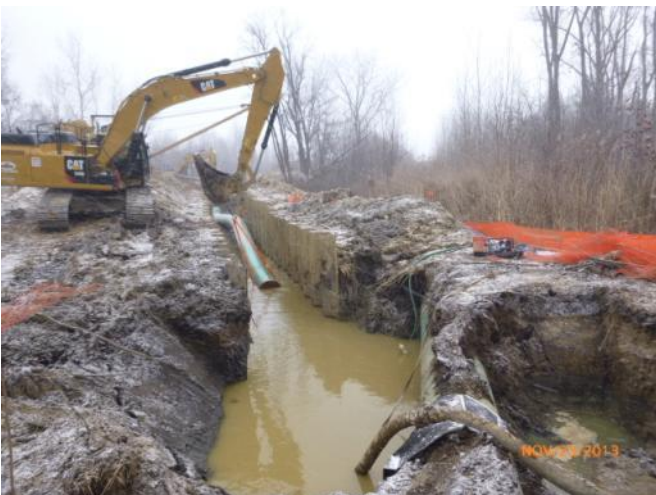
Vector Cross-over trench Sta.# 1585+12 looking East.

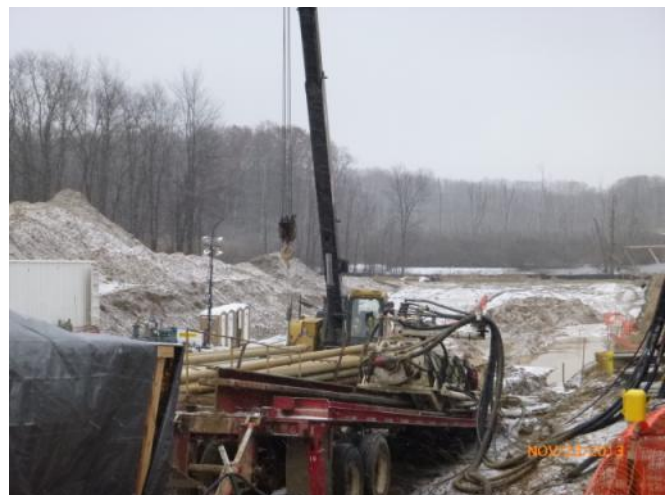
HDD of w-517-e snowy conditions Sta.# 2765+87 looking East.
